PIER –Environmental Area

■ Avian Research Program Transmission- Distribution Line Issues

Linda Spiegel
June 28, 2005

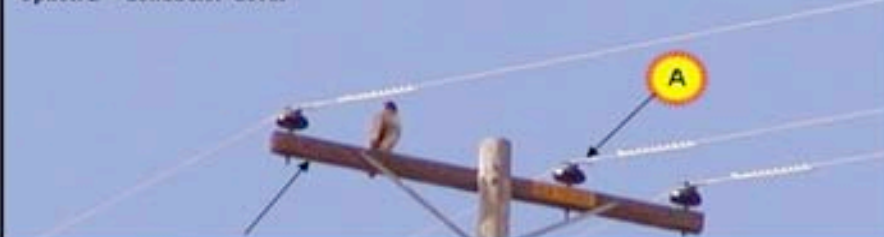
DISTRIBUTION POLE TOP, 3 WIRE, SINGLE ARM, TANGENT, FLAT TOP

Option 2 – Conductor Cover
